# Stormwater Detention Basin Enhancement

## Friendship Community Center, Lower Paxton Township, Dauphin County, Pennsylvania

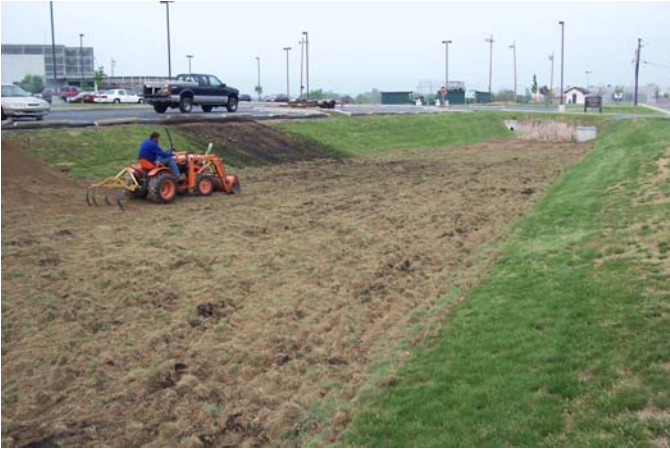
Plowing the east basin floor before sowing the area with meadow grasses and forbs

The least successful aspect of this project involved the attempt to create a biodiverse wetland and wildflower meadow on the floor of the now-plugged east basin (shown being plowed in the photograph on the opposite page). This effort was largely unsuccessful because rain puddled and re-sealed the cultivated soil surface before volunteers could be mobilized to spread the seed, rake it in, and cover potential ponding areas with mulch and matting (to prevent the seed from floating away). Clearly, retrofitting a more natural wet meadow community on the floor of a functioning detention basin needs to happen as a single and complete activity, with seeding and stabilizing the surface following immediately on the heels of surface tilling.

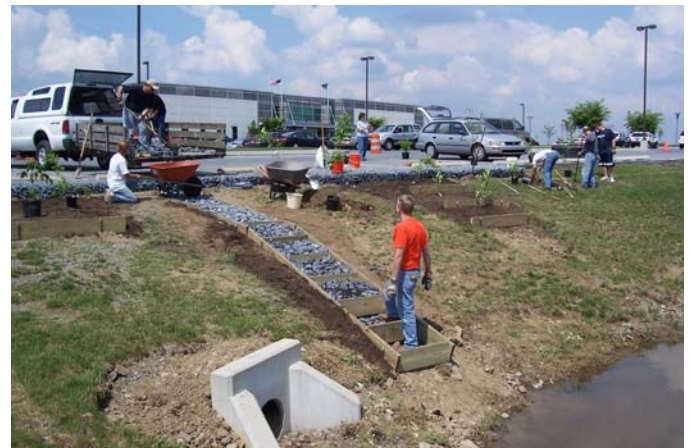
Installation of the water ladder for runoff erosion control

Because the basins had been constructed in mixed rocky fill materials (not topsoil), turfgrass growth has always been sparse around the basins. Uncontrolled parking lot runoff along the north edge of the west basin had caused particularly significant soil erosion in this area. With manual labor provided by local Boy Scout Troop 368, erosion-control devices installed here included 1) a rock-filled gabion basket "verge" along the edge of the parking area (to promote infiltration of pavement runoff), 2) plank "checks" to create soil-filled planting benches, and 3) a treated lumber "water ladder" to stabilize a gully.

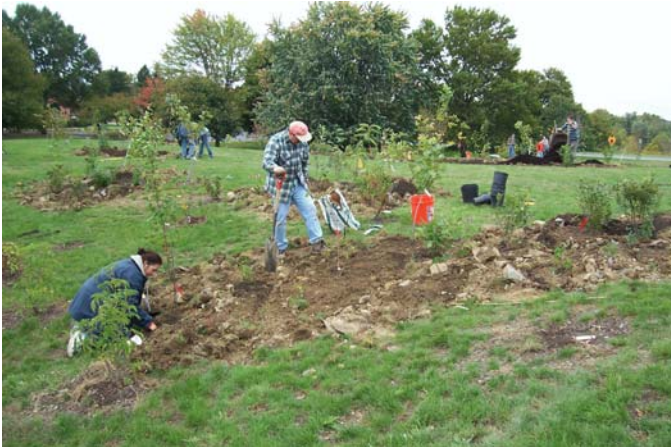
Planting in clusters and within larger plowed zones promotes better plant survival in derelict soils

Ecological restoration planting techniques were utilized to enhance plant survival in the stony, compacted and sterile soils around the detention basins. First, planting areas were thoroughly loosened by either excavating extra large planting pits using a tractor-mounted auger or by plowing up more extensive planting “zones” for cluster plantings. These efforts alone will promote both better rainwater infiltration and improved plant establishment.
